# NATIONAL FERTILIZERS LIMITED, NANGAL UNIT

# REVAMP OF STEAM TURBINE FOR SYNTHESIS GAS COMPRESSOR AT NFL NANGAL

National Fertilizers Limited, Nangal Unit, India had under taken the revamp of Steam Turbine of Synthesis Gas Compressor in January 2014. The plant startup, after machine revamp, was delayed by 40 days, because of various activities related to machine revamp which were not envisaged before commencement of the revamp. This paper throws light on those unforeseen jobs which lead to delay in startup and the lessons learnt to avoid such delays in future.

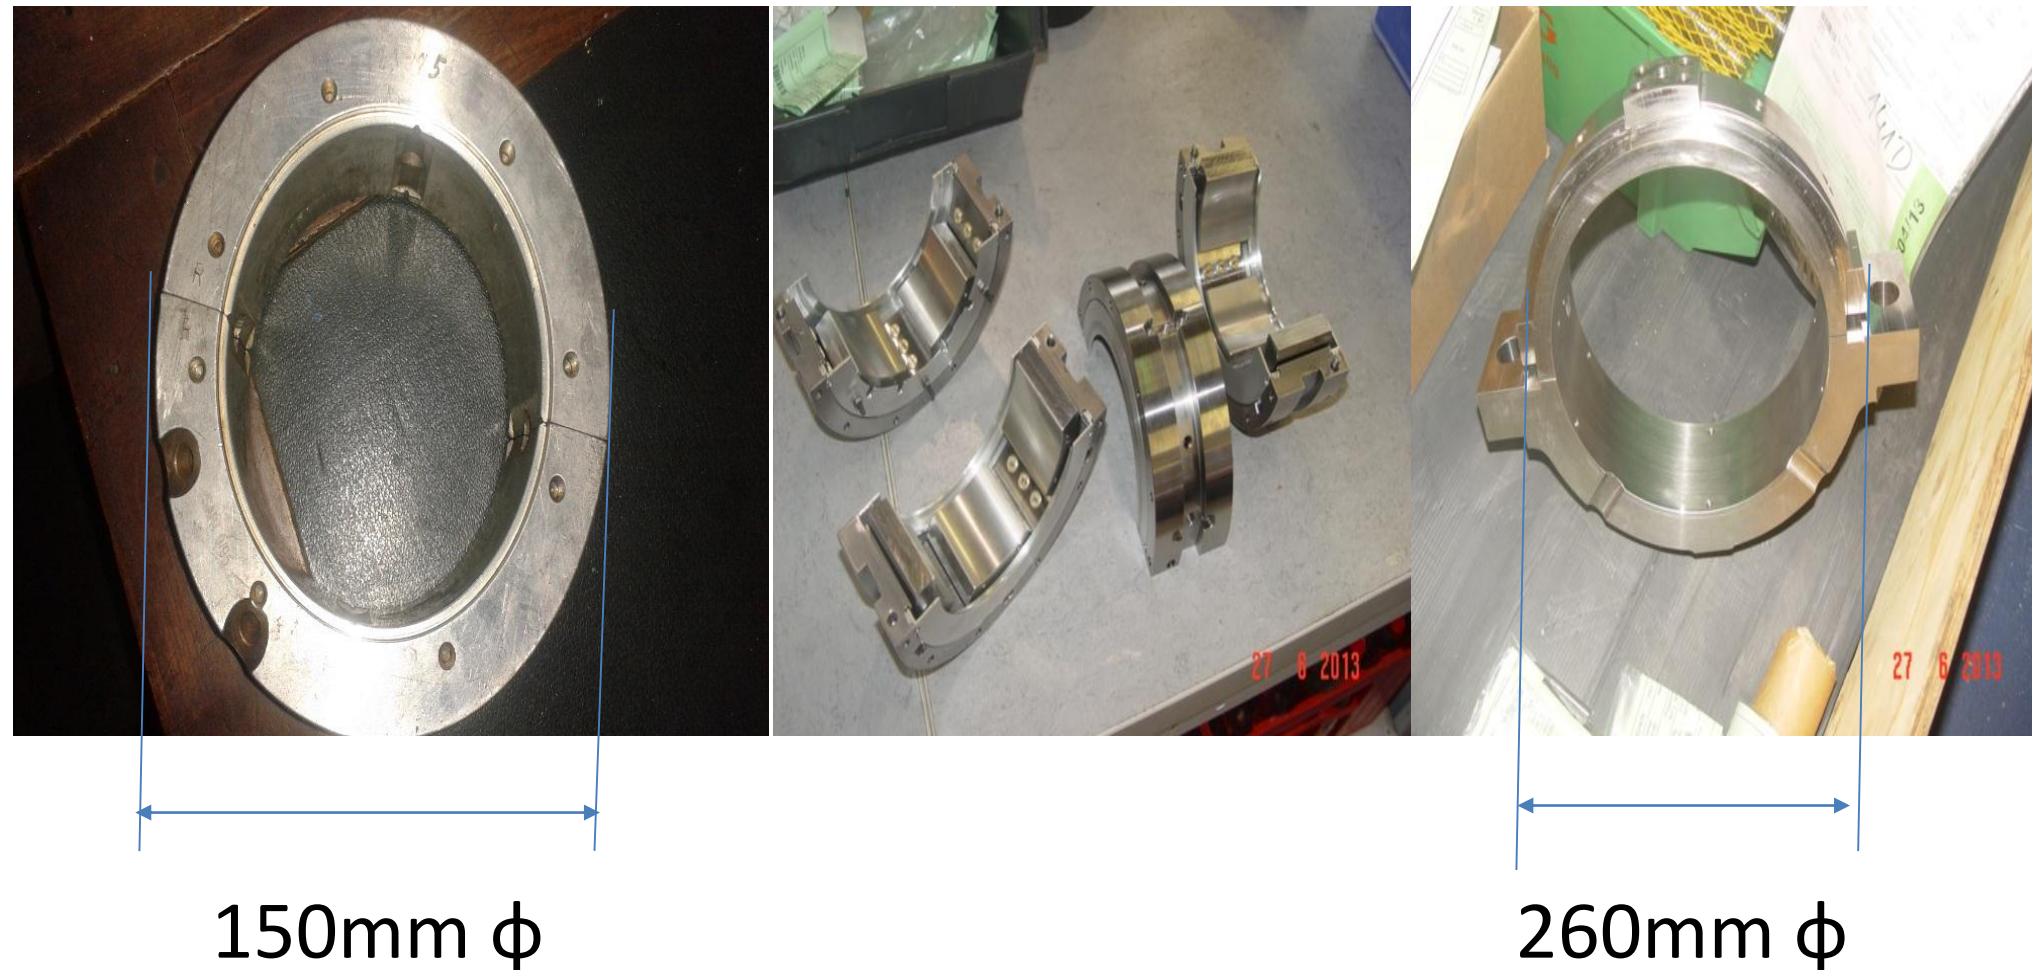
JOURNAL DIAMETER OF THE NEW ROTOR WAS 124.83 MM AGAINST THE ORIGINAL ONE AS 119.82MM.

DESIGN OF BEARINGS WAS CHANGED TO TILTING PAD TYPE INPLACE OF BUSH TYPE.

# MODIFICATION OF SEATING AREAS OF FRONT END BEARING PEDESTAL

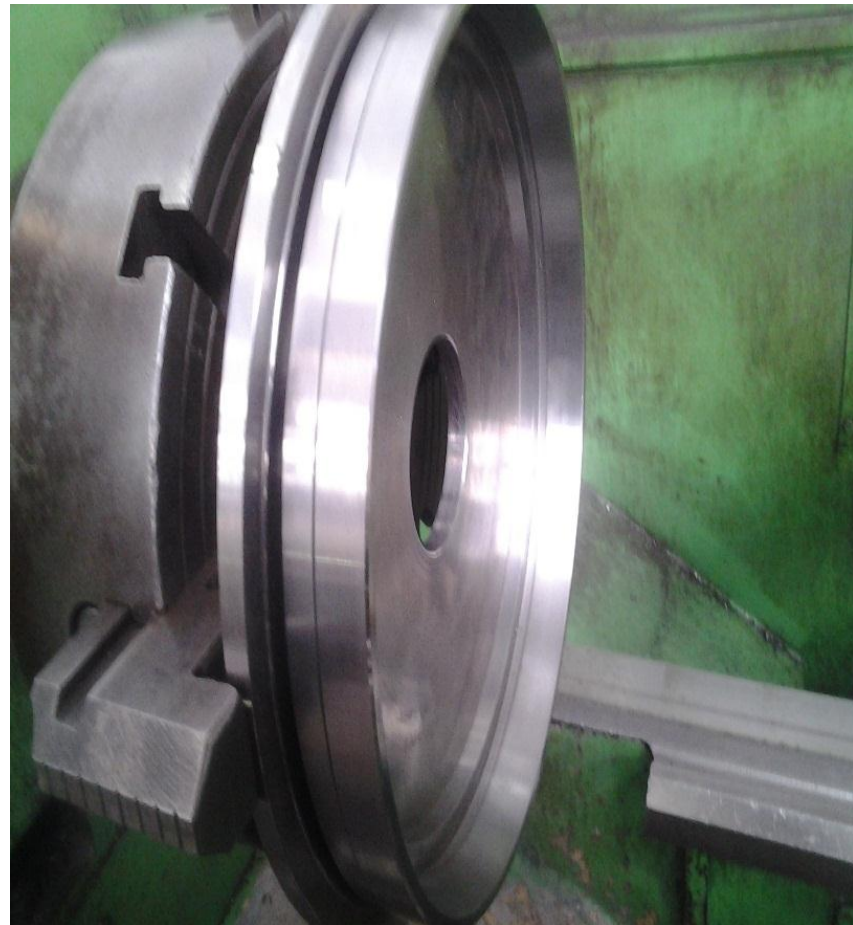
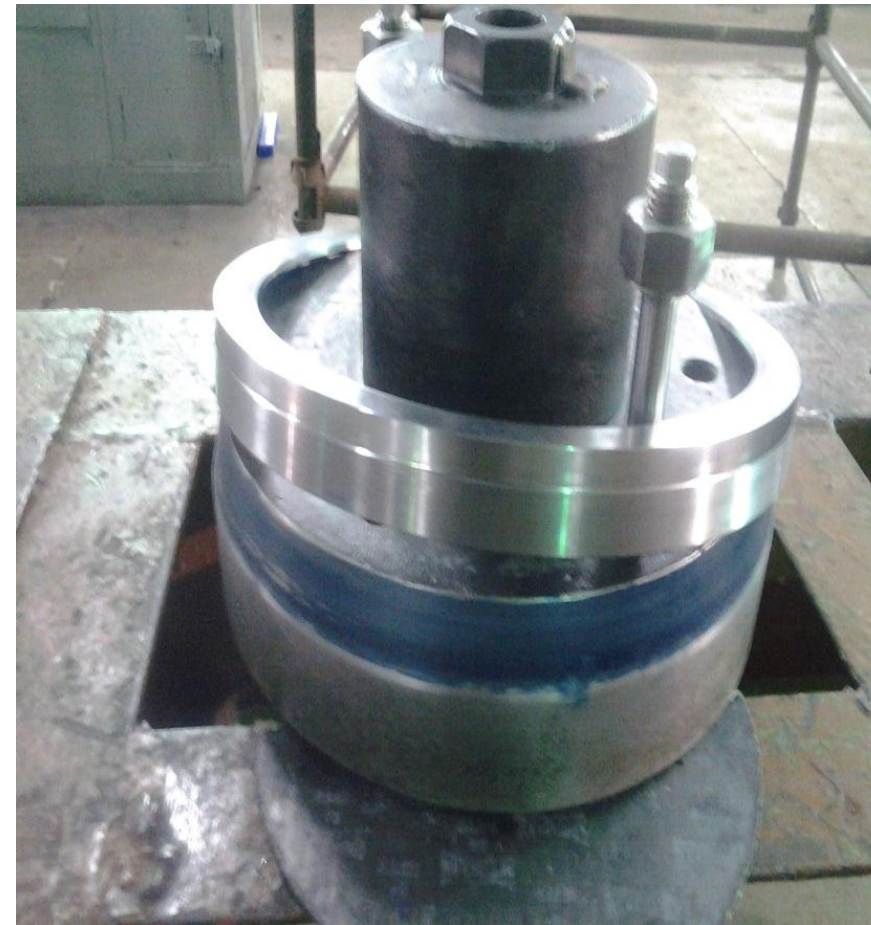
**DELAY DUE TO WRONG SEALING ANGLE OF THE OF SEAL RING ON  
EMERGENCY STOP VALVE 25 DEG. INSTEAD OF 15 DEG.**

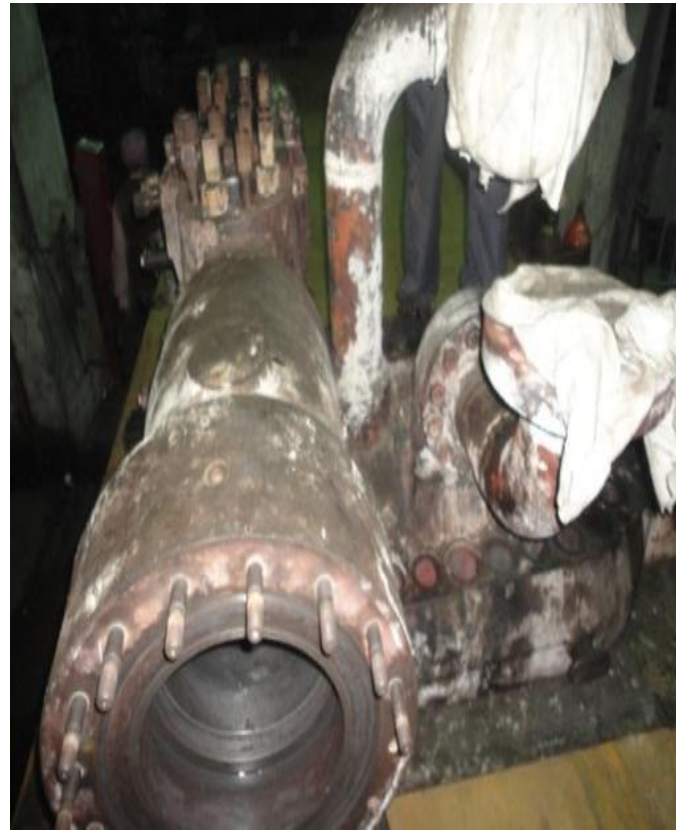
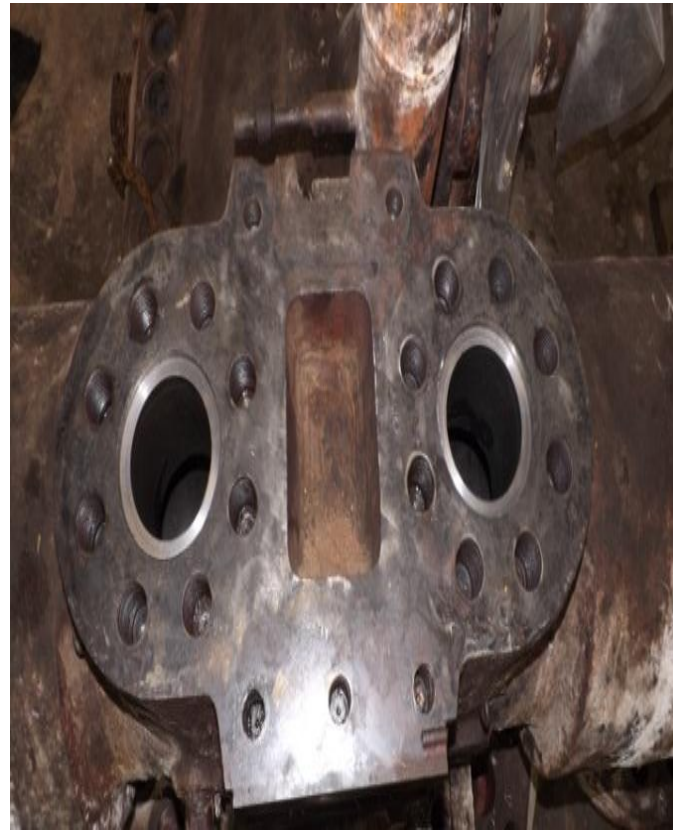
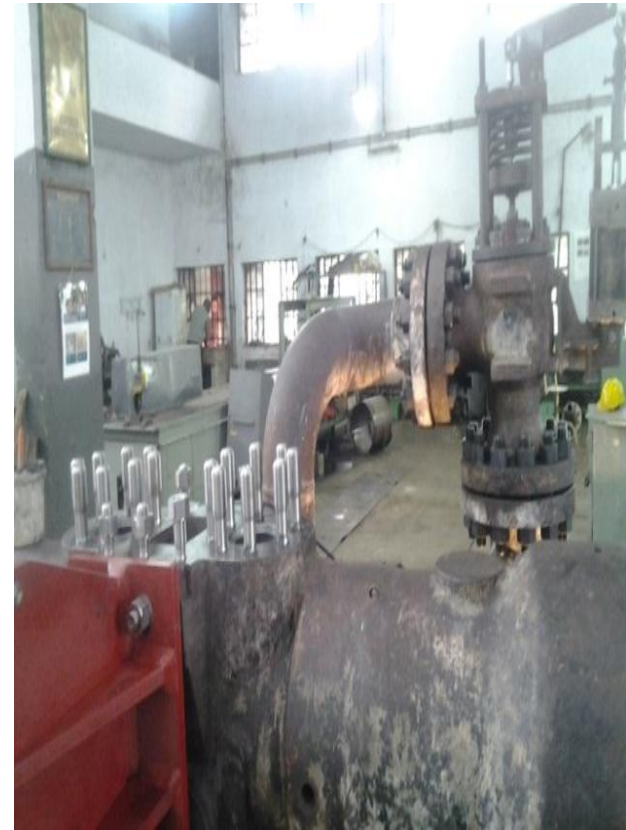
# REMOVAL OF DAMAGED STUDS IN TOP CASING

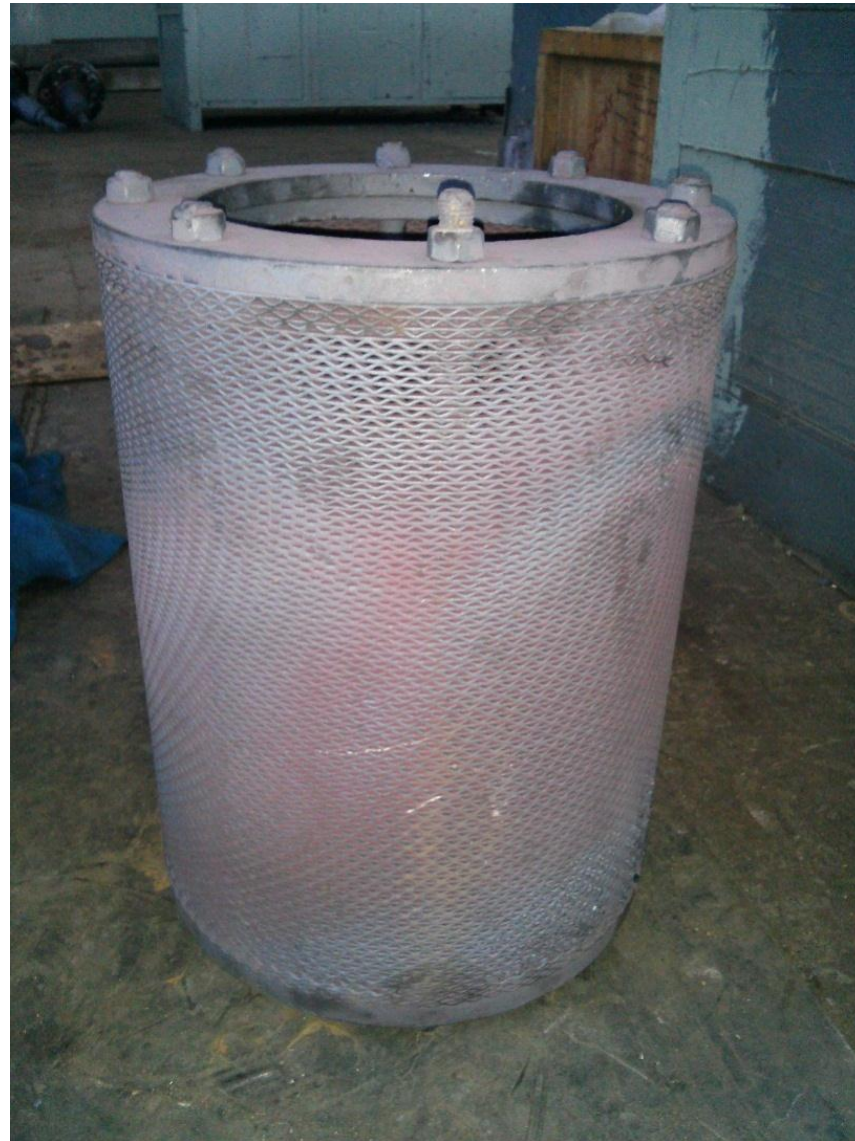
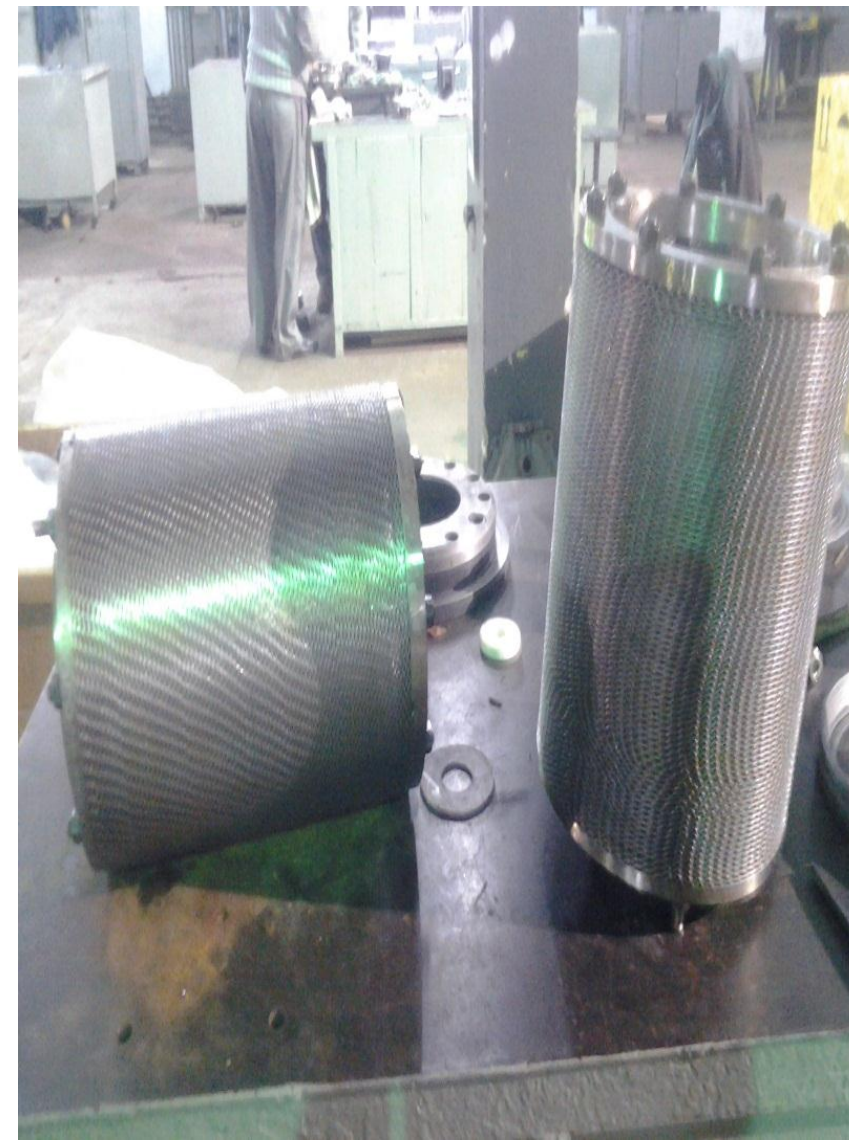
# REPLACEMENT OF STRAINERS IN THE MAIN STEAM INLET LINES. THE JOB REMAINED HELD UP DUE TO NON AVAILABILITY OF SPARE STRAINERS

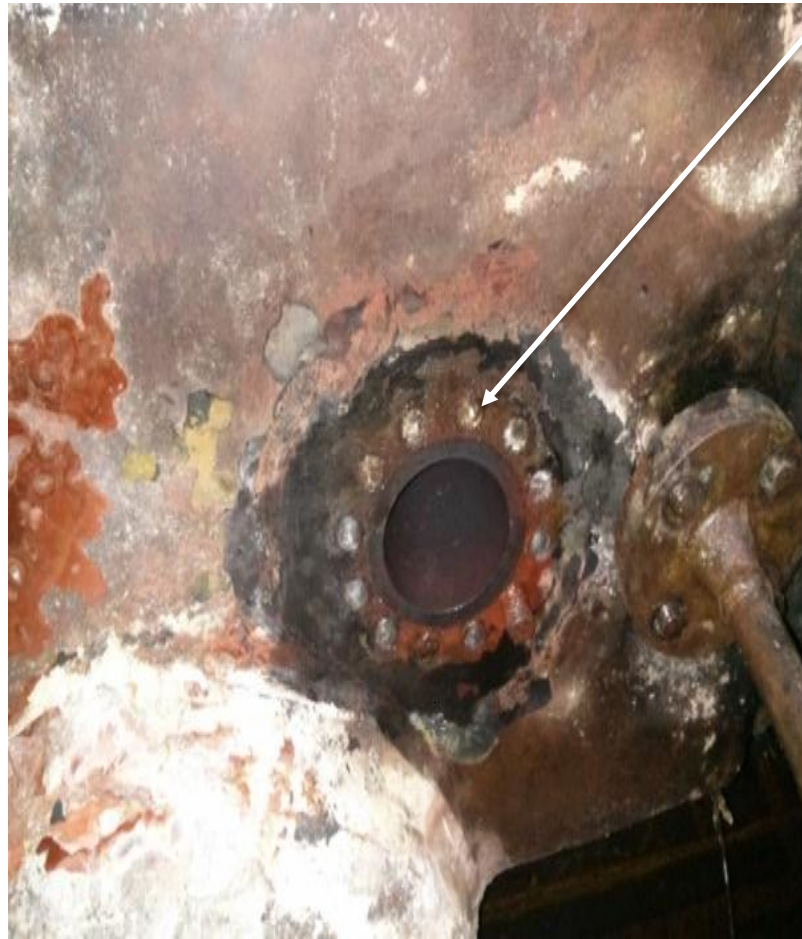
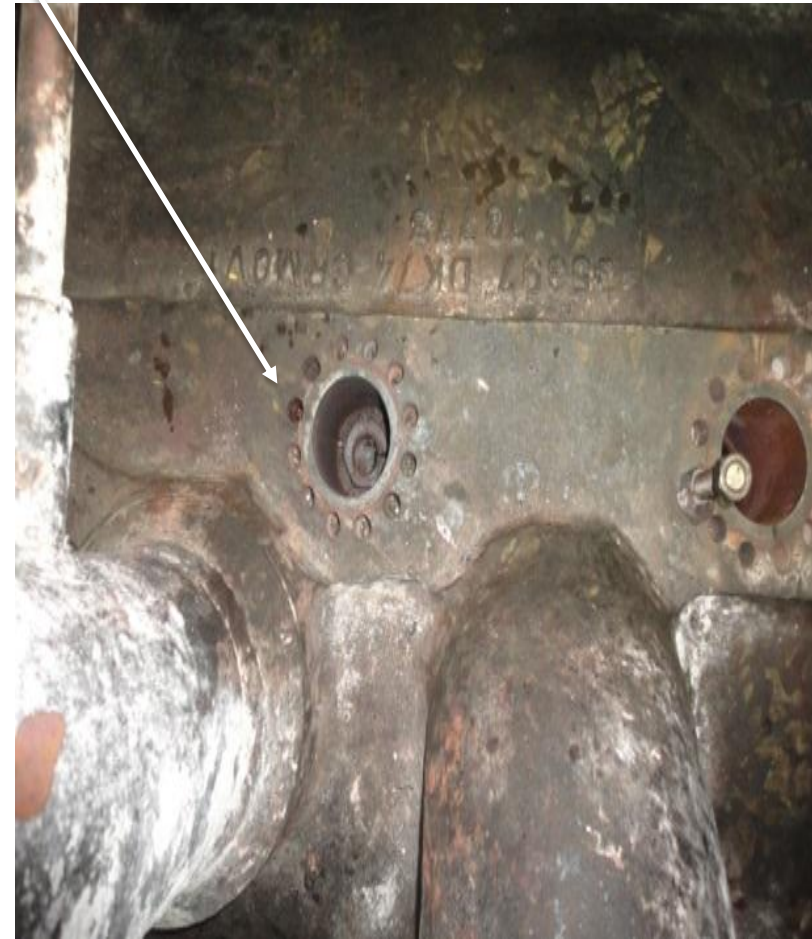
# REPLACEMENT OF ALL OLD DAMAGED STUDS INSTALLED IN THE BOTTOM CASING

BROKEN BOLTS/STUDS IN THE  
BOTTOM CASING

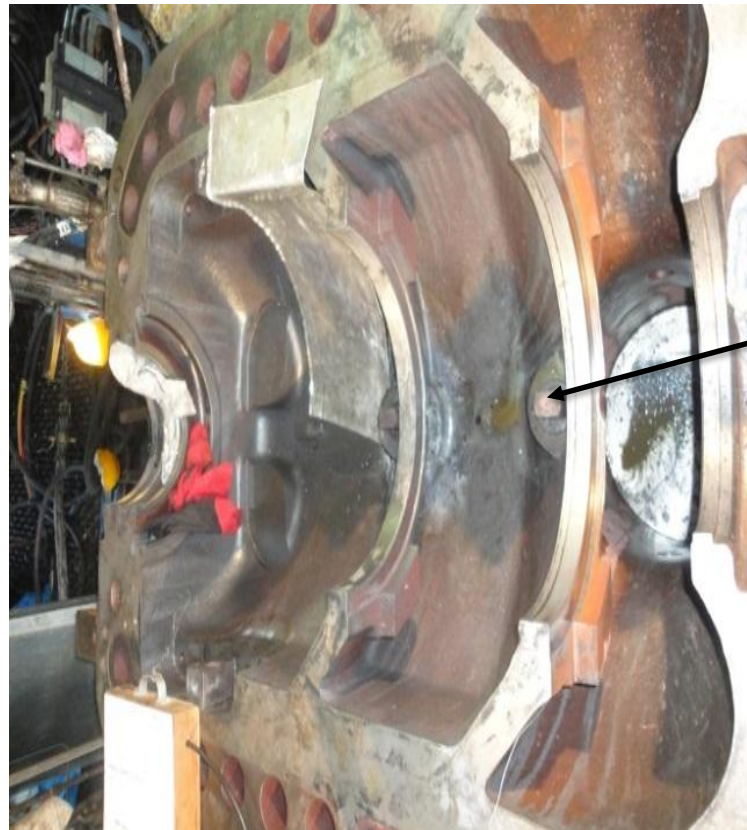
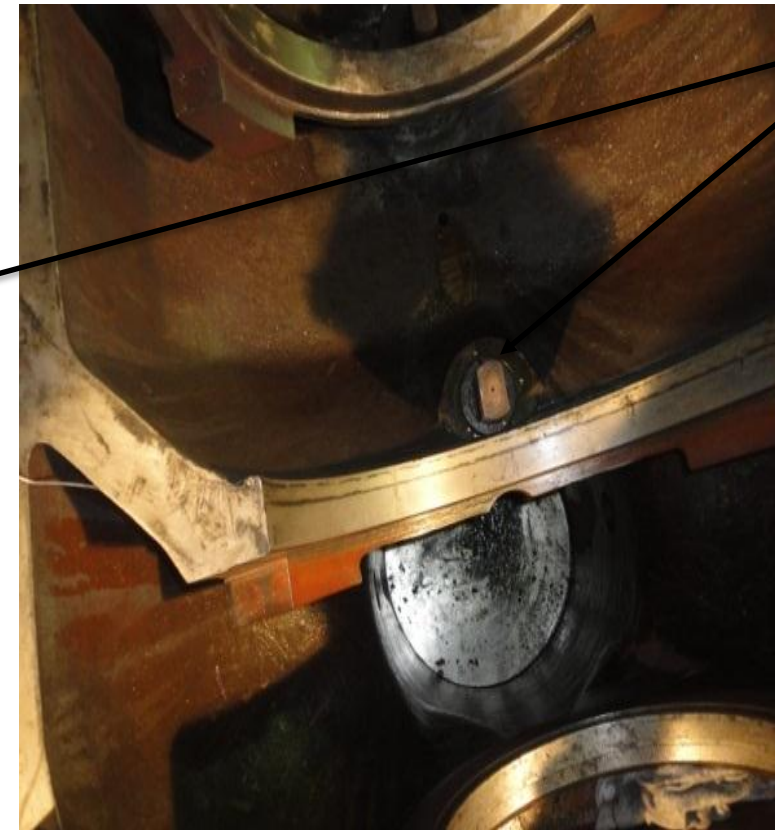
CENTRE  
GUIDE KEYS

# SHIFTING OF BOTTOM CASING TO MECHANICAL WORKSHOP FOR REMOVAL OF CENTER GUIDE KEYS & ECCENTRIC BUSHES

**BASIC REFERENCES OF BOTTOM CASING W.R.T  
FOUNDATION AND BEARING PEDESTALS LOST**

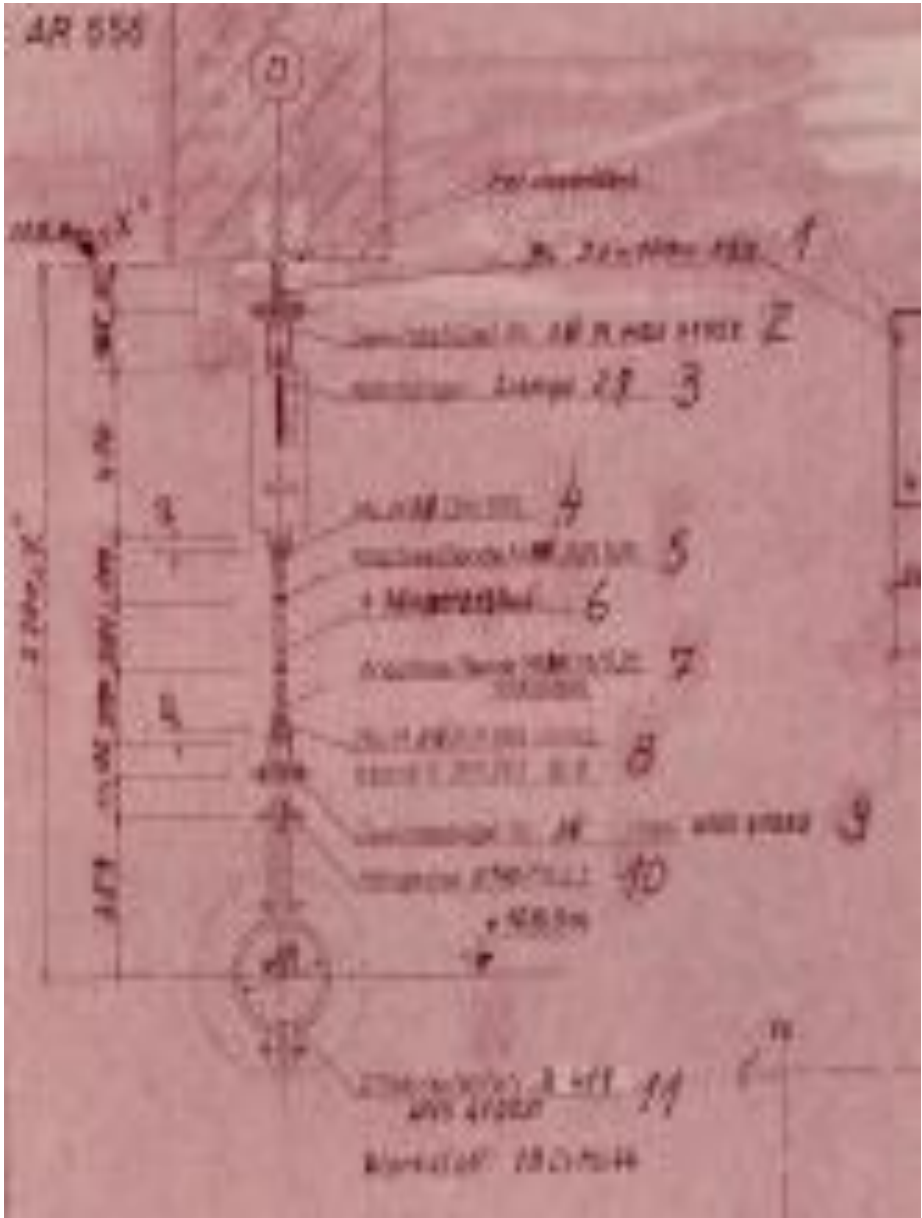
# SPRING SUPPORTS WERE FOUND BADLY RUSTED AND FEW WERE FOUND DAMAGED

New set of Spring Supports may be kept available

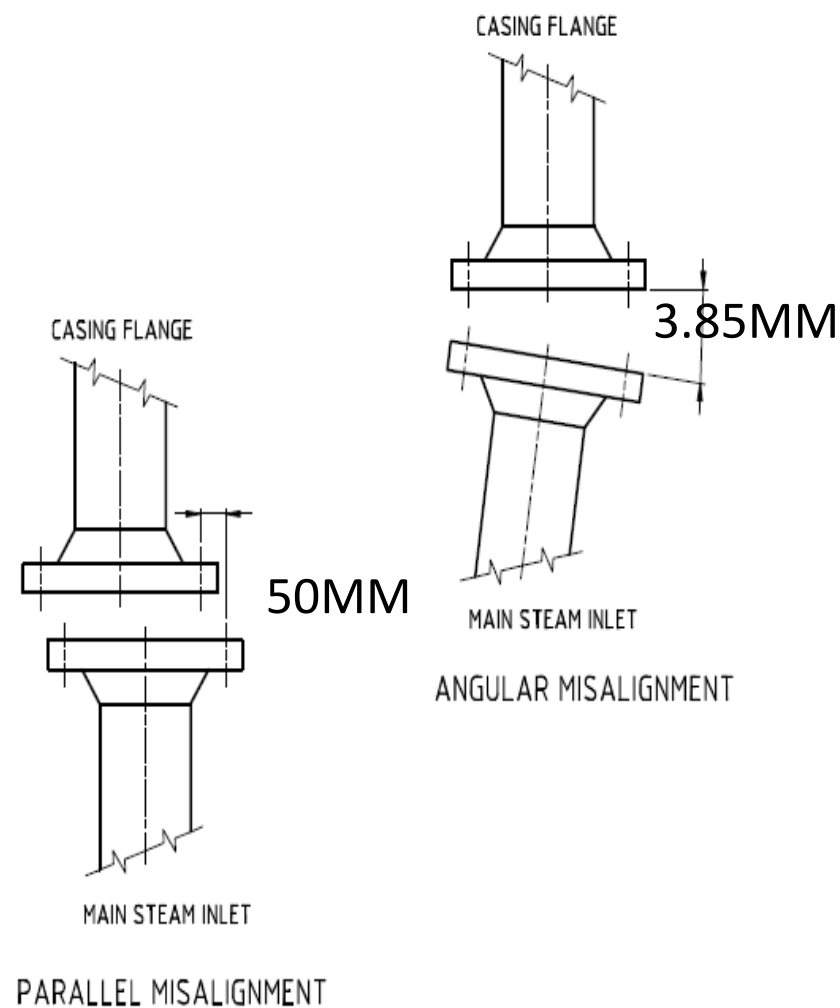
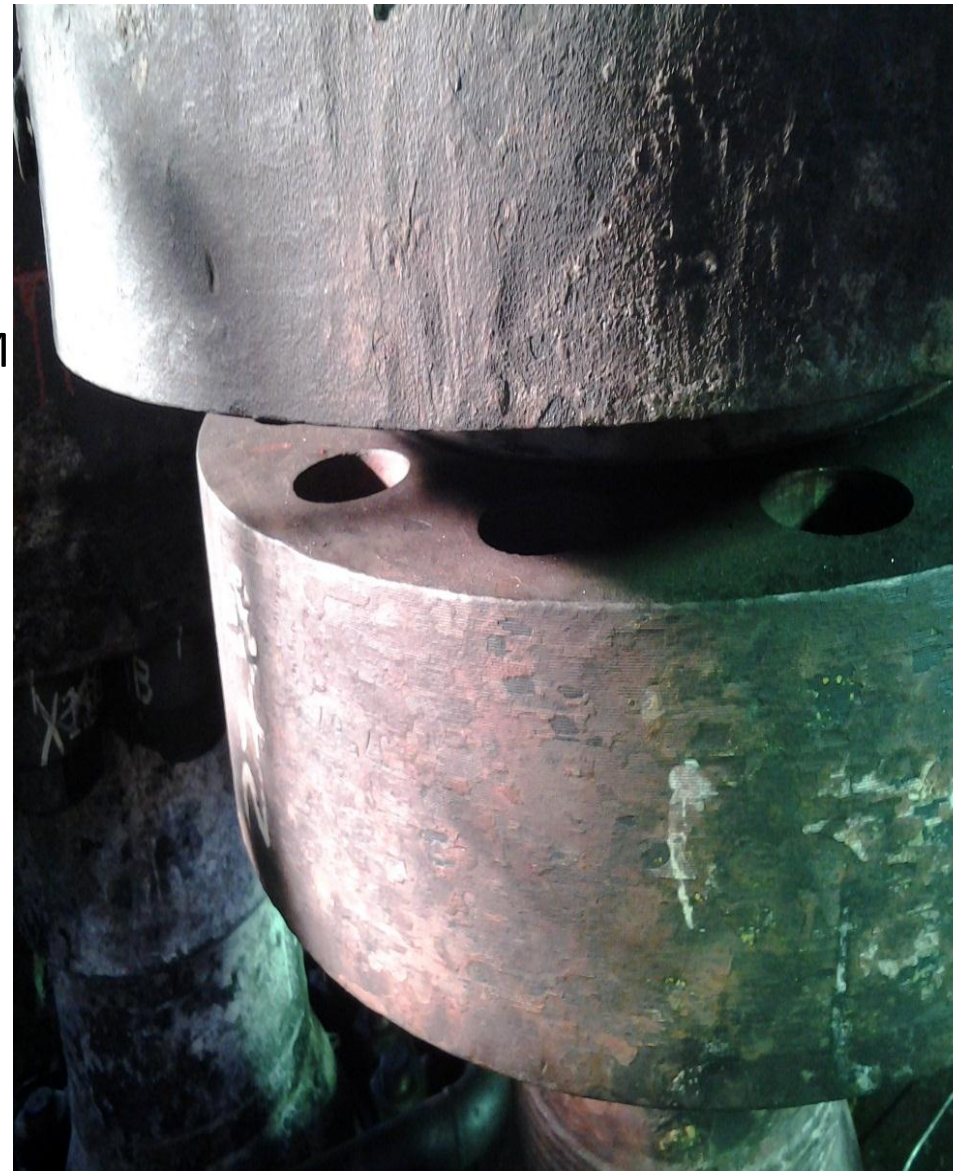
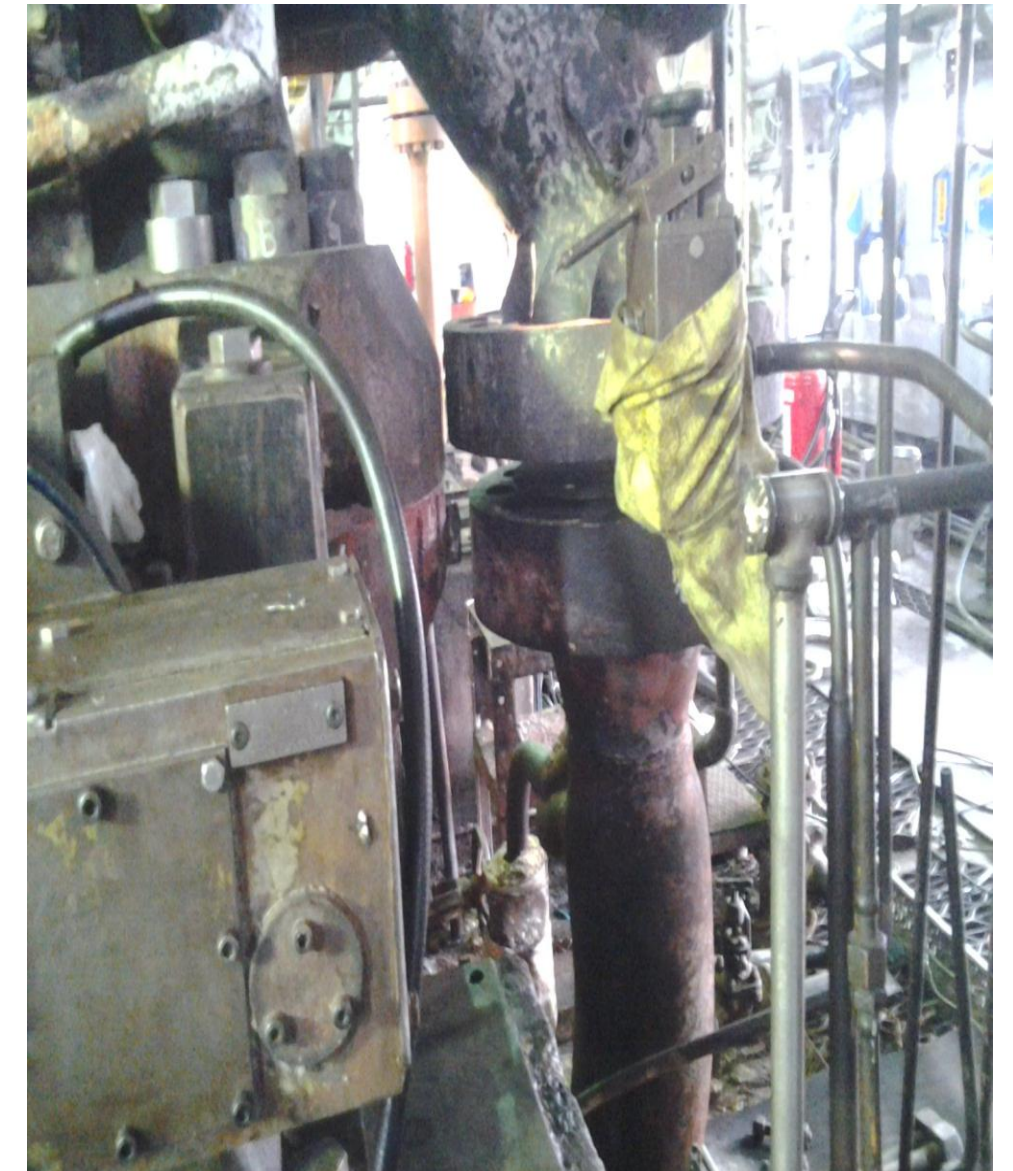
# MISALIGNMENT OF STEAM INLET FLANGES

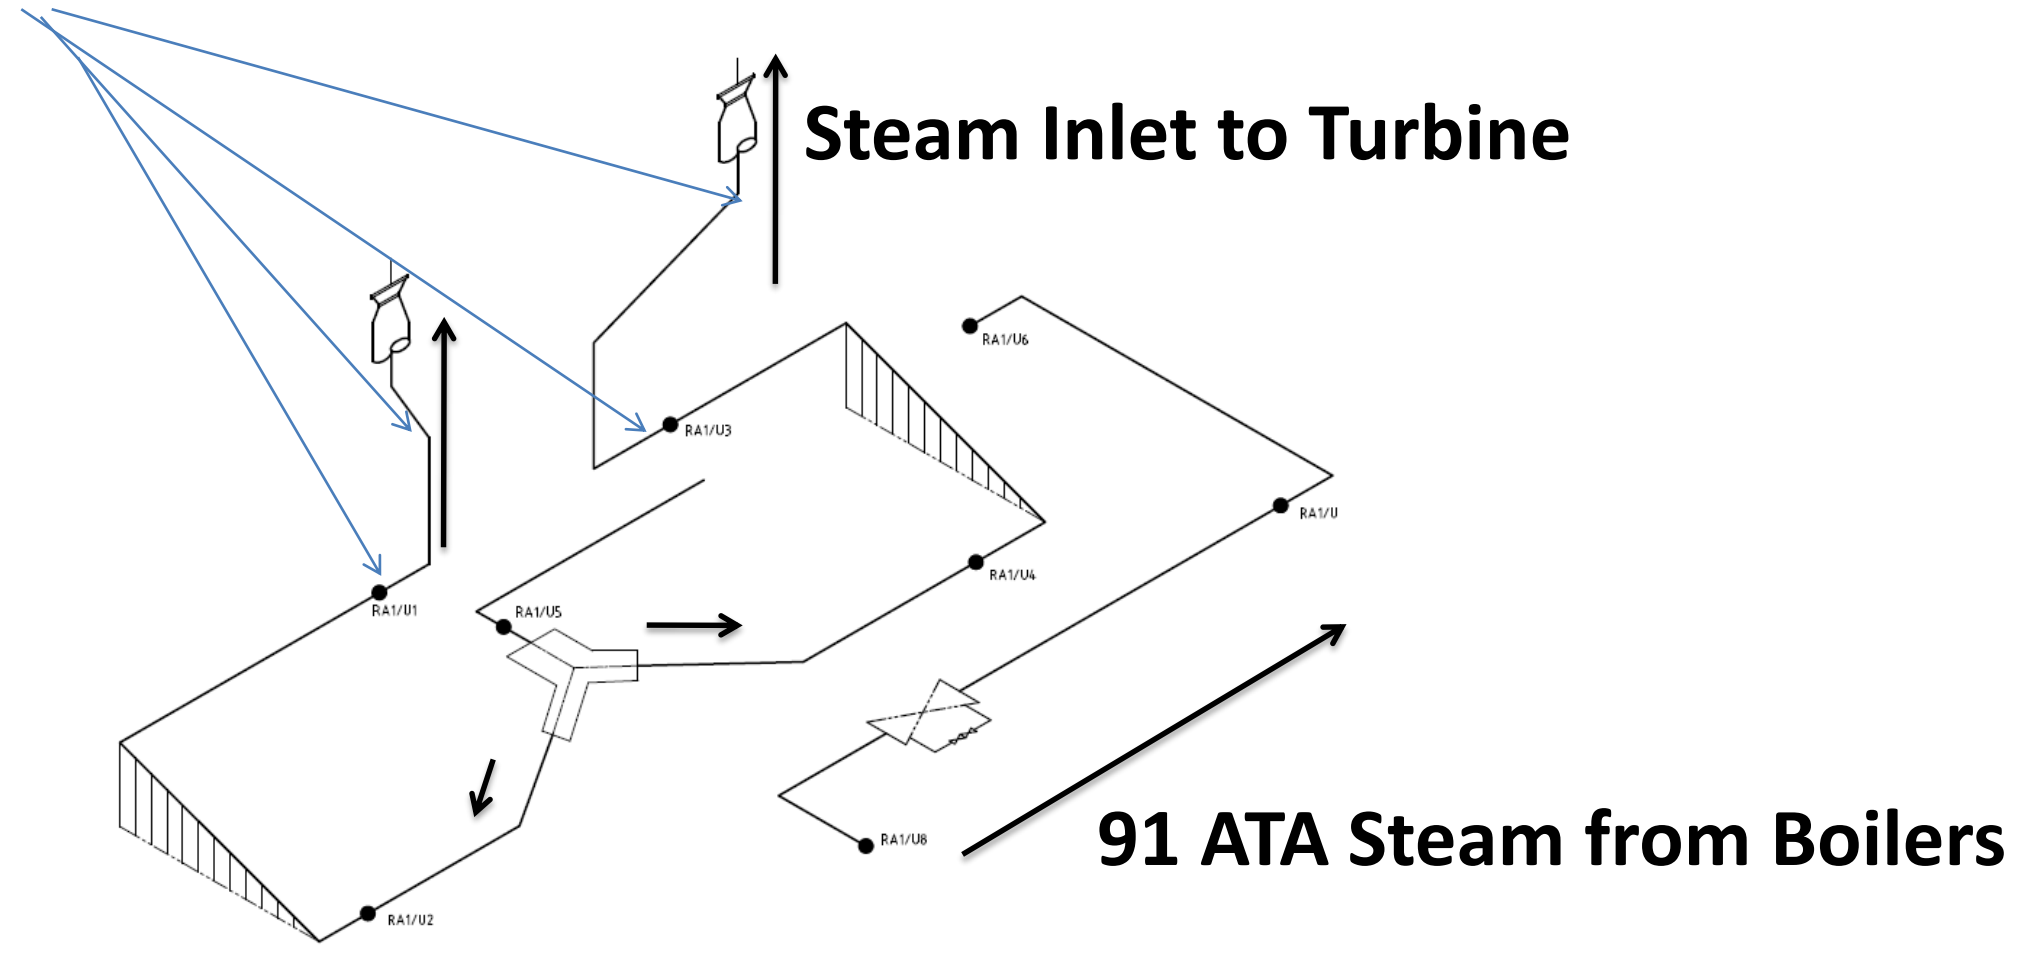
# **CORRECTION OF PIPING MISALIGNMENT BY CUTTING AND REWELDING THE HIGH PRESSURE/HIGH TEMPERATURE STEAM PIPING**

## Welding Joints cut and Pipe relocated

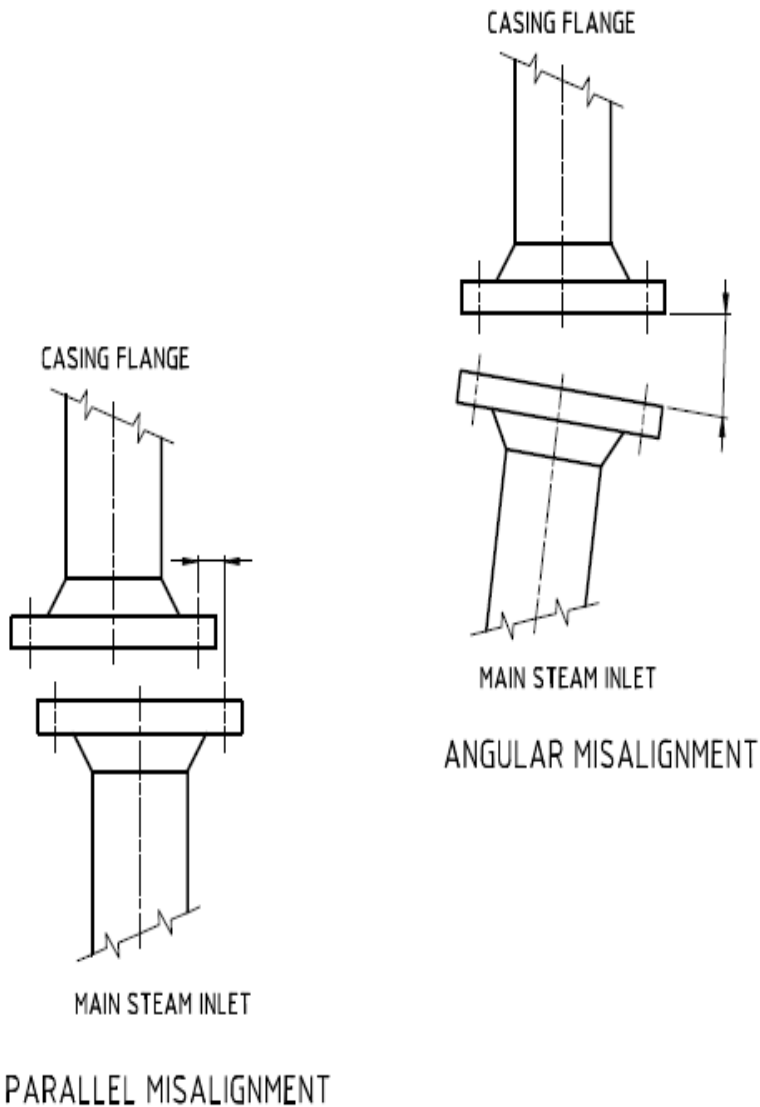
# MISALIGNMENT OF STEAM INLET FLANGES

S. No.	Description	Main Steam Flange(Left)		Main Steam Flange (Right)	
		Before Correction	After Correction	Before Correction	After Correction
1	Parallel Misalignment, in mm	50	2	45	2.5
2	Angular Misalignment, In mm	3.85	0.10	2.30	0.10

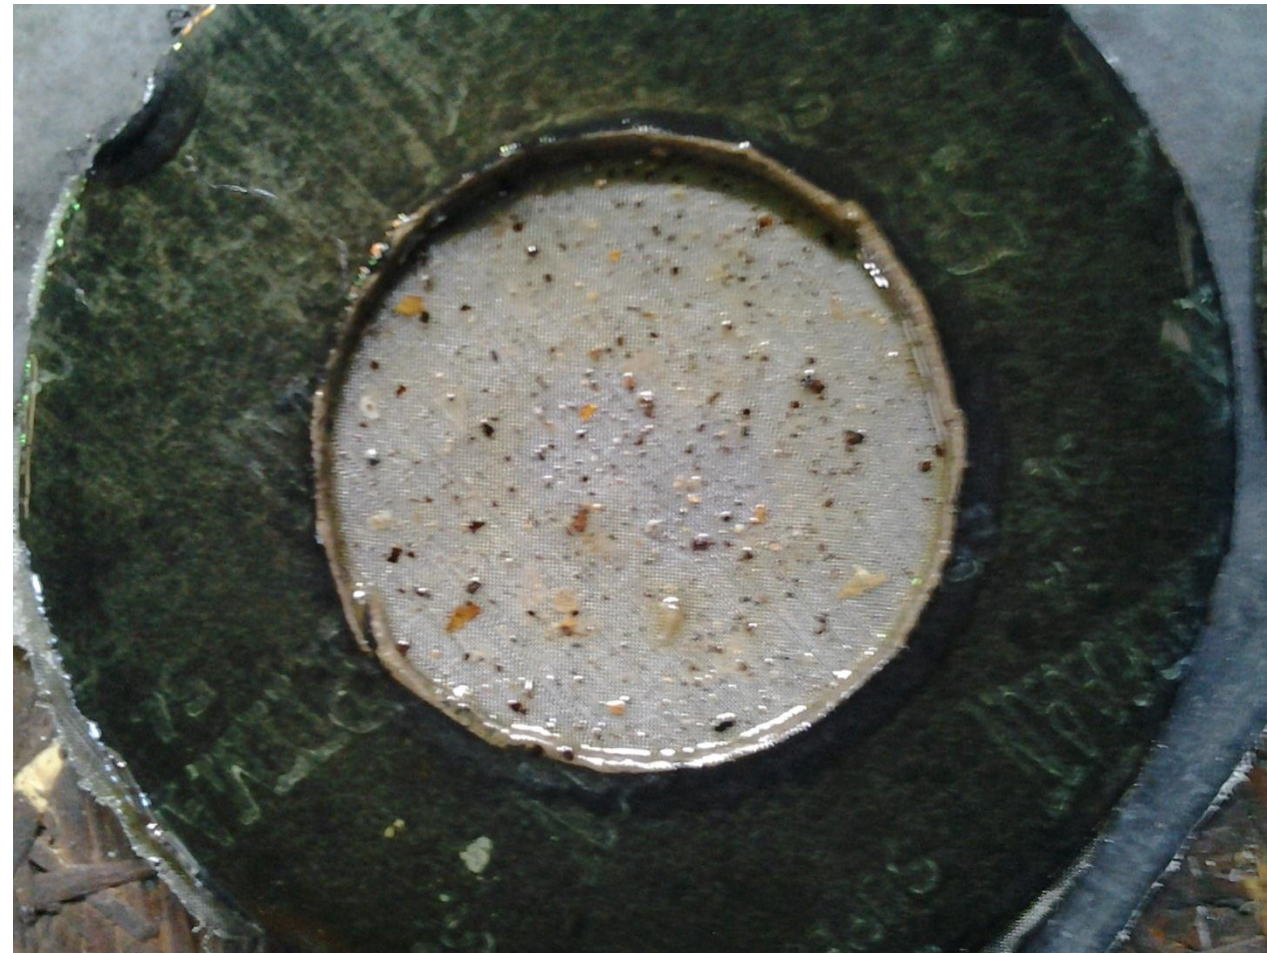
TEMPORARY STRAINERS WERE INSTALLED IN THE  
OIL PIPING FOR CLEANING OF LUBE OIL

Cleaning of Lubricating Oil well in advance
